EFFECTS OF INDUCED DAMAGES ON THE FLEXURAL FATIGUE BEHAVIOR OF GLASS FIBER REINFORCED PLASTIC (GFRP)

*Wong Teck Kai and Ha How Ung
Faculty of Engineering,
Universiti Malaysia Sarawak,
Sarawak, Malaysia
Phone: (60) 82-671000 Fax: (60) 82-672317
Email: donaswtk@yahoo.com*

ABSTRACT

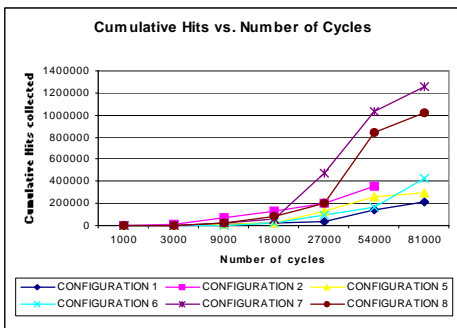
Figure 8: Cumulative Hits recorded over number of Cycles

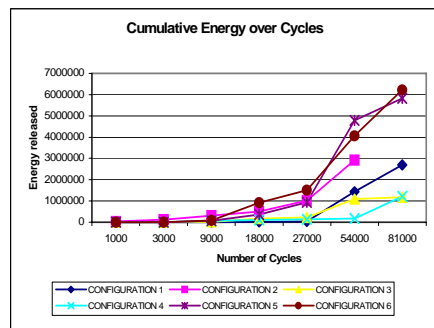
Figure 9: Cumulative Energy collected over number of Cycles
